# Equipment Inspection

LANYARD- DAMAGE PHOTOS

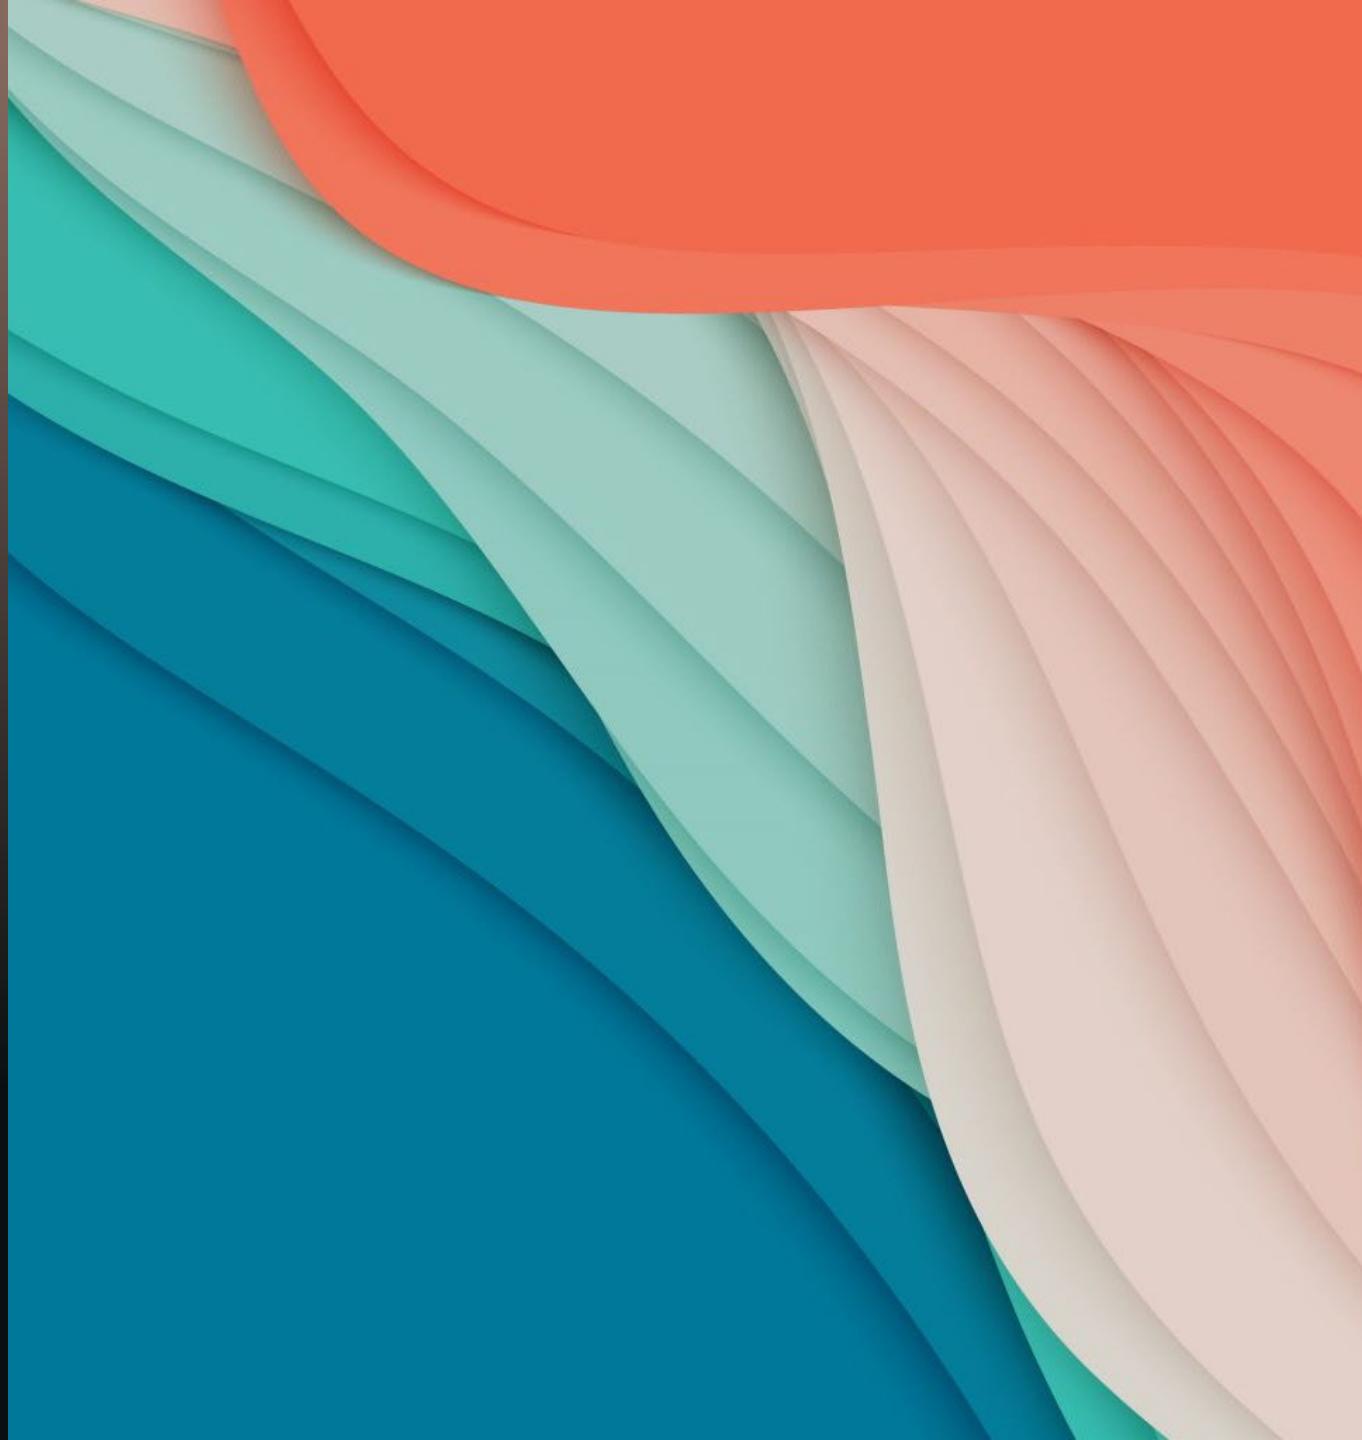
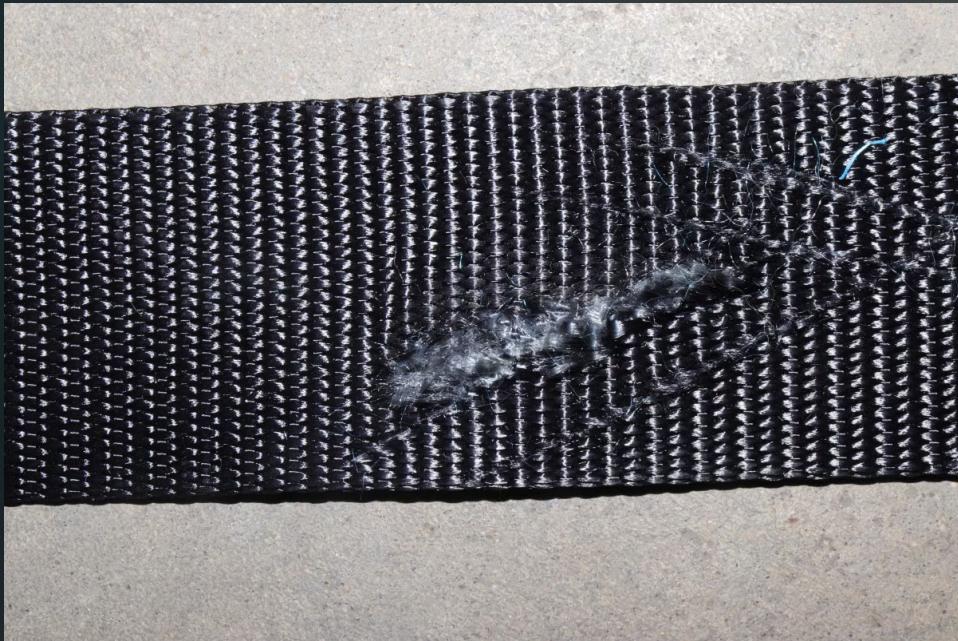
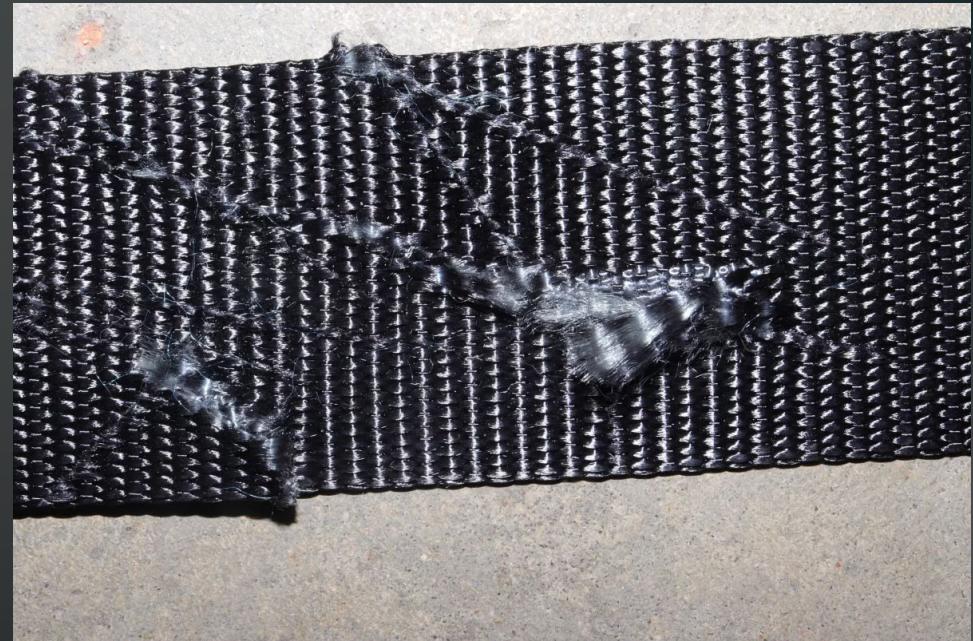
Fraying

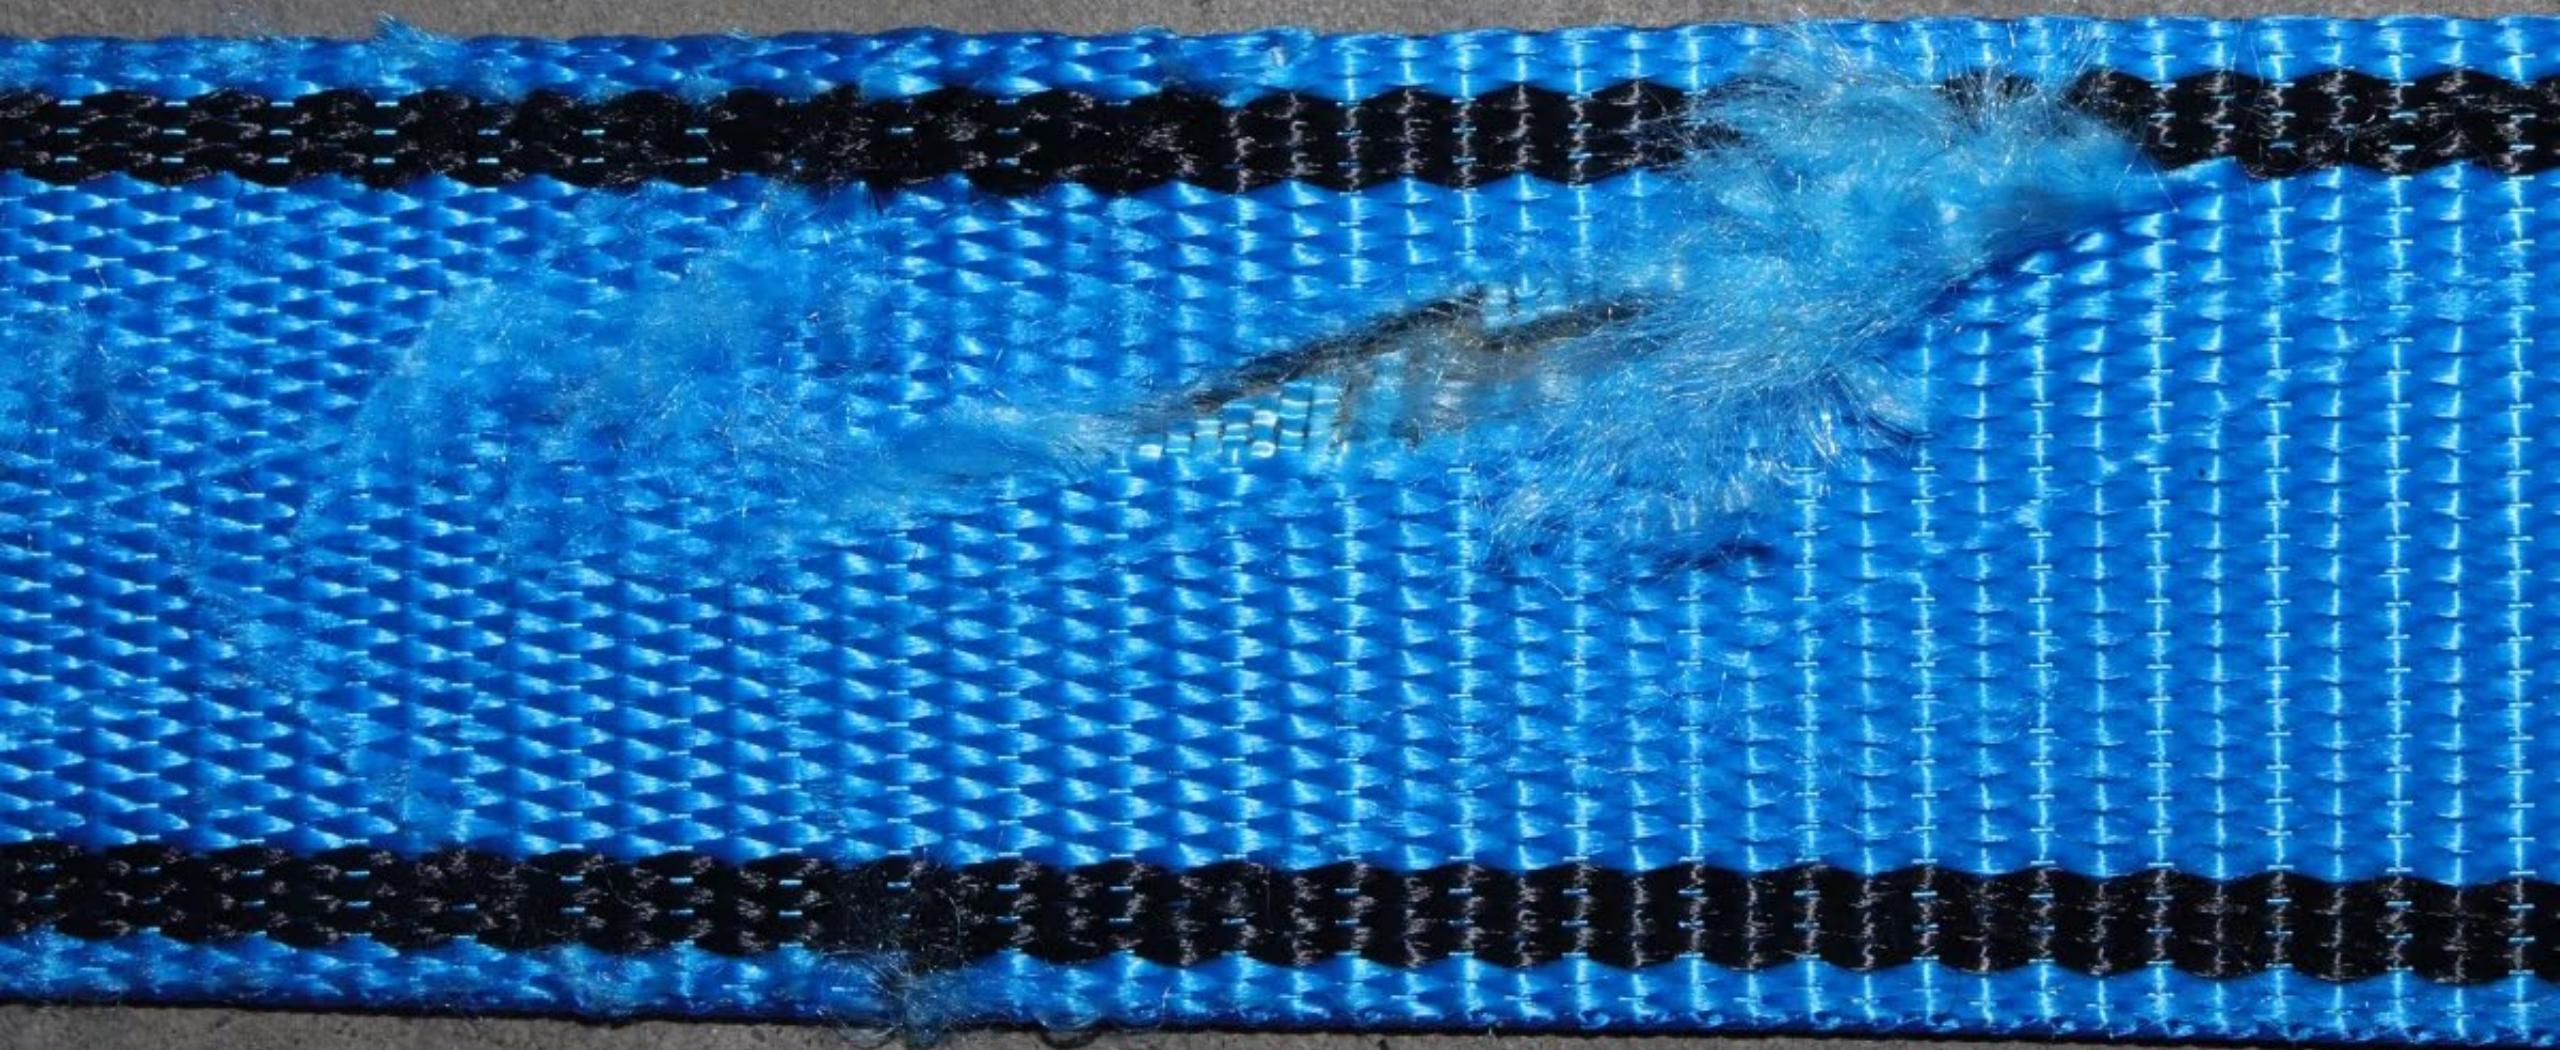
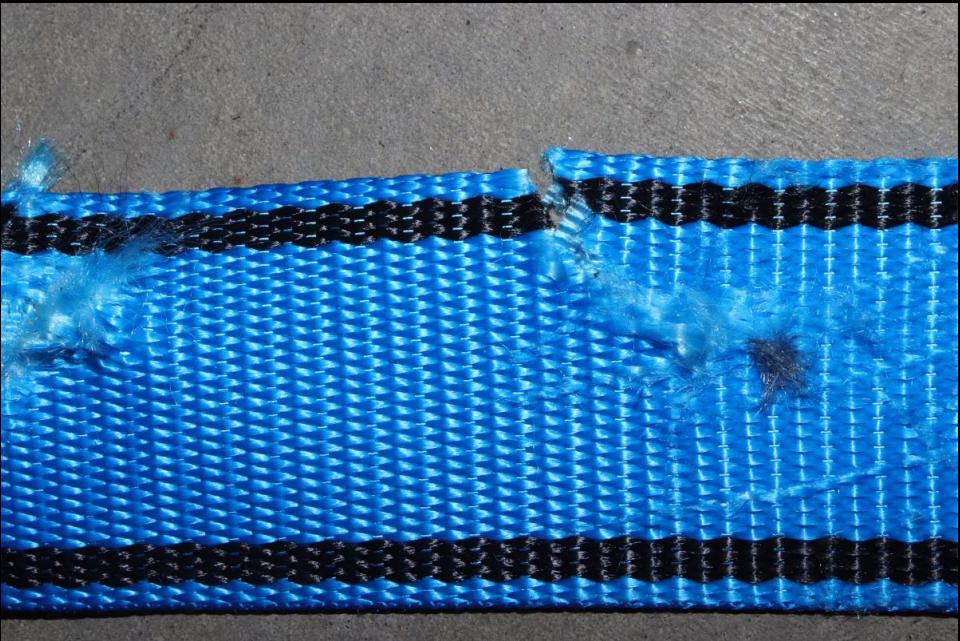
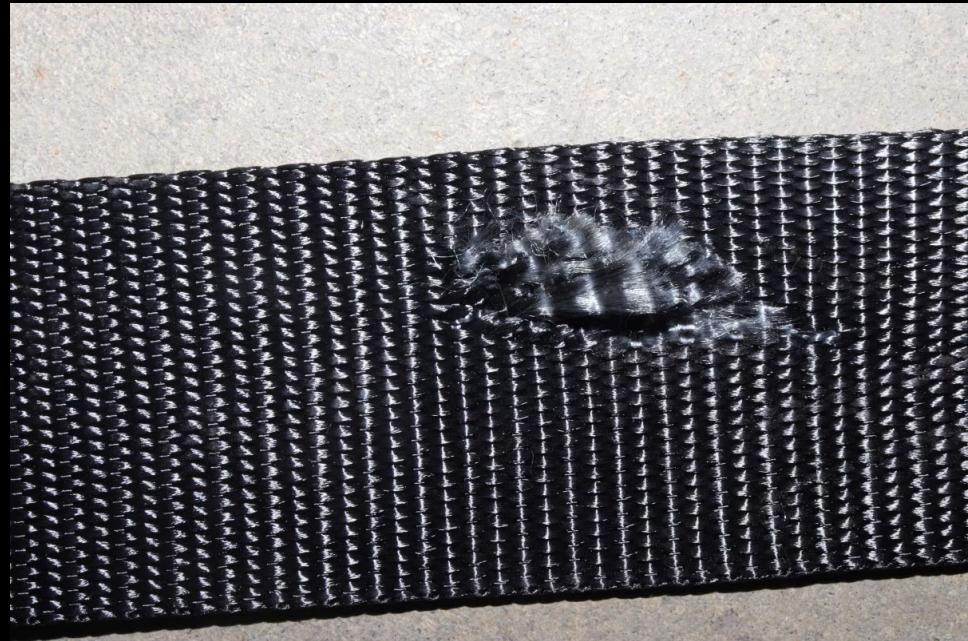
Cut and Fraying

Fraying due  
to an added  
point of  
friction

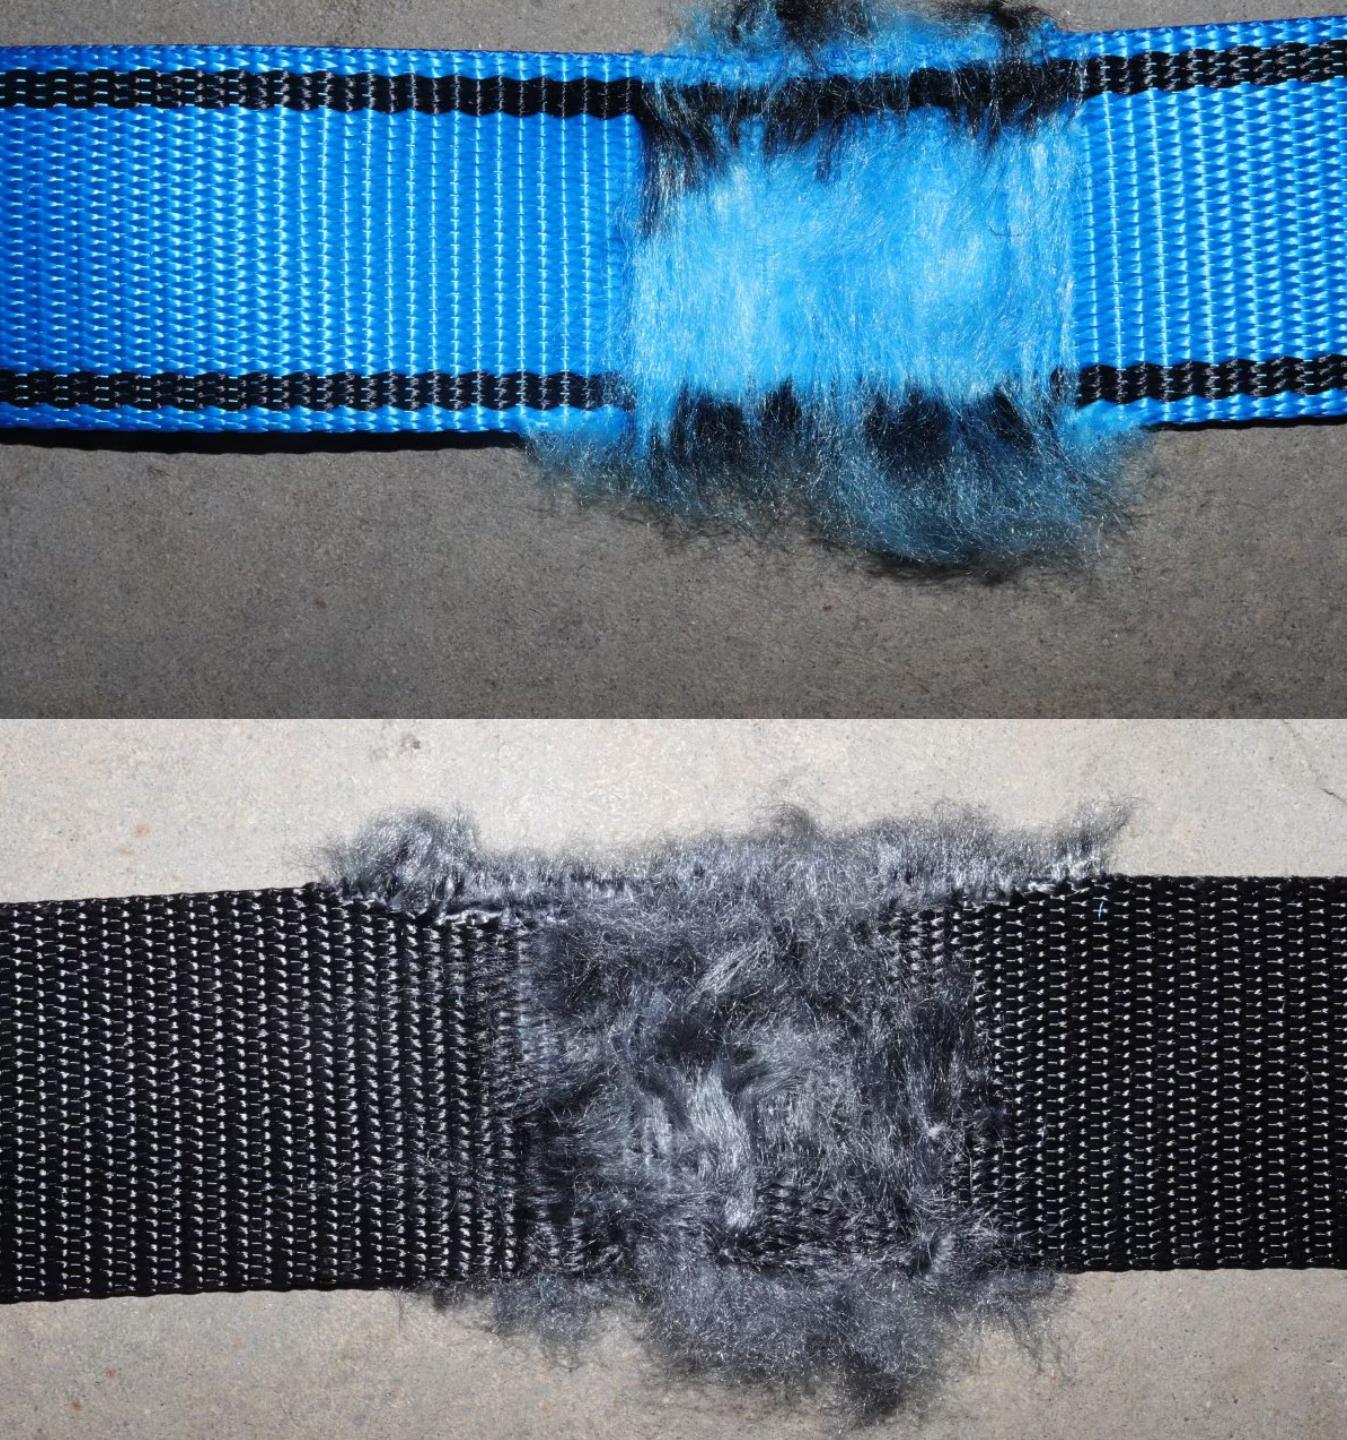
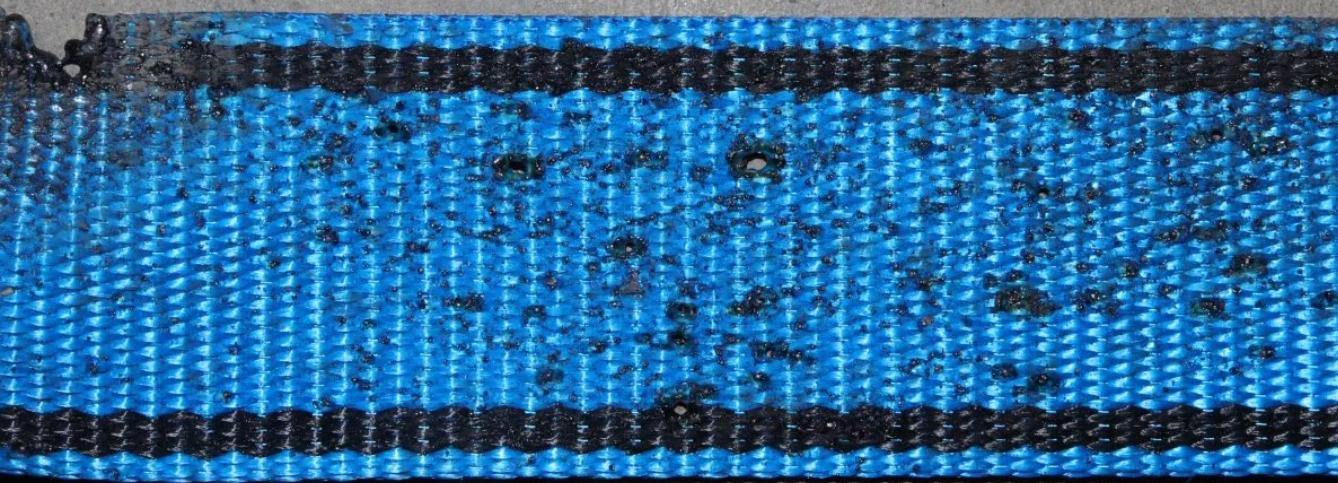
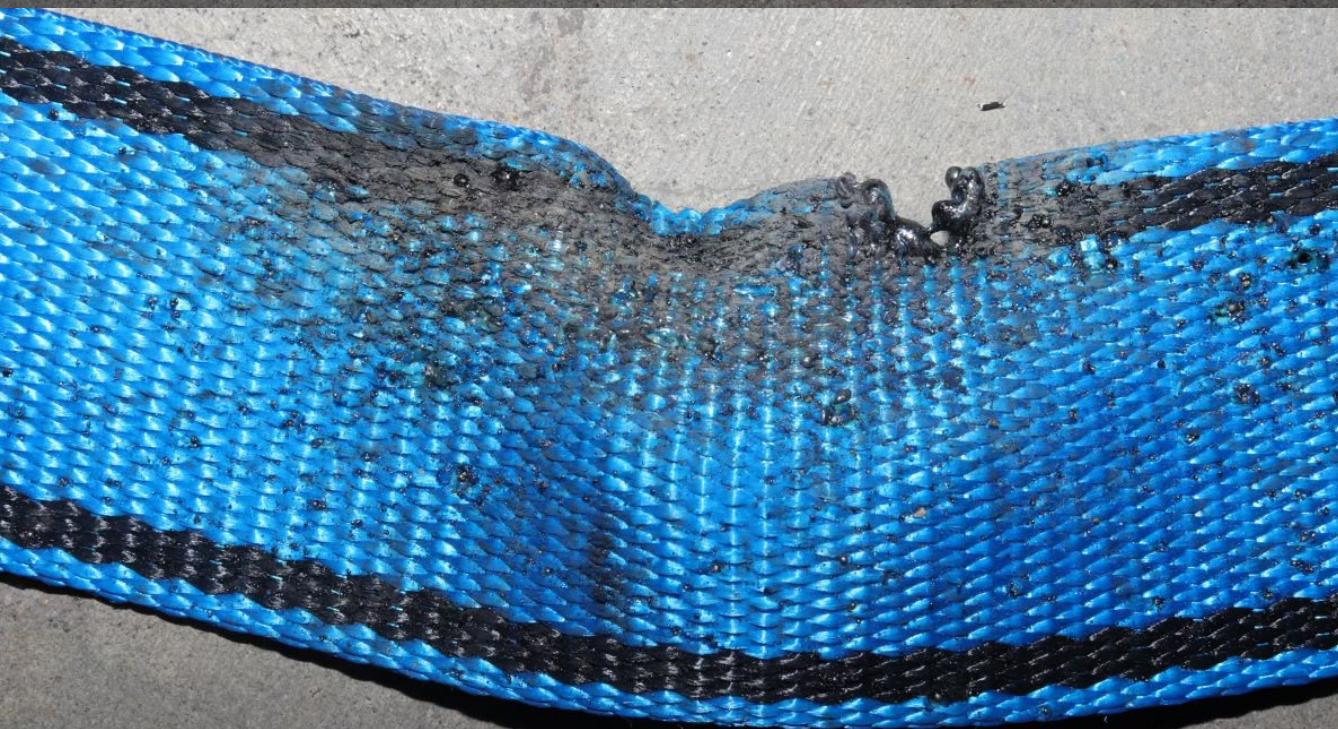
Welding  
Splatter
